Contaminated Sites

Environment Australia, 1999
Best Practice Environmental Management in Mining
ISBN 0 642 546460

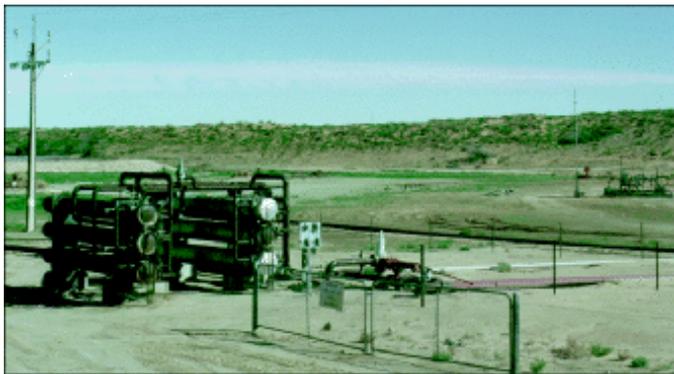
Feed to Tirrawarra line, Meranjin Field, South Australia.

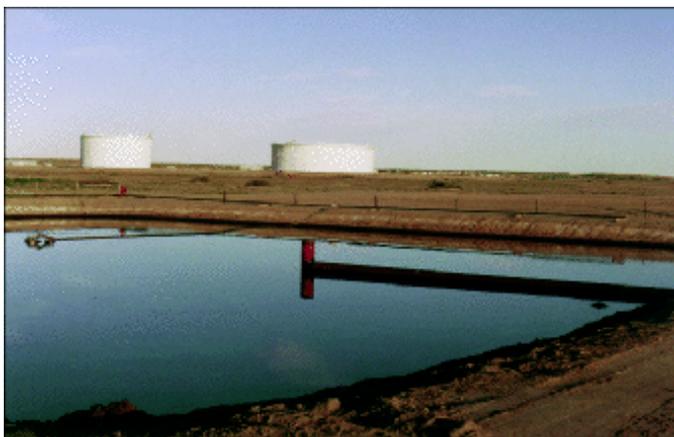
Moomba facility, South Australia. A new oil interceptor pond to collect stormwater from floating roof hydrocarbon tanks.

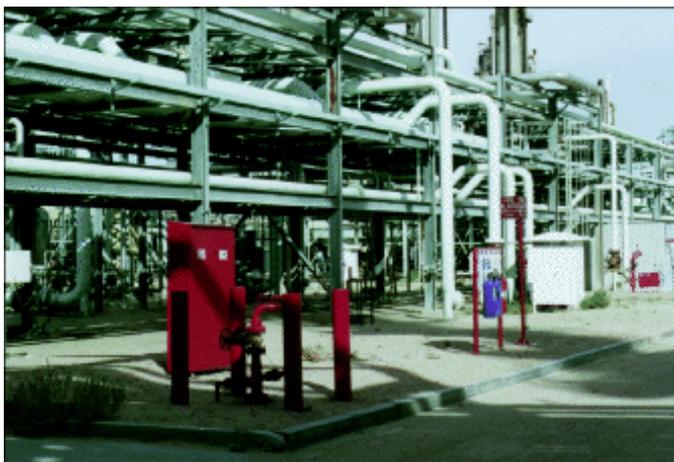
PHOTO: SANTOS LIMITED

Santos is committed to maintaining emergency and safety equipment such as this fire alarm and extinguisher in top condition at all their facilities.

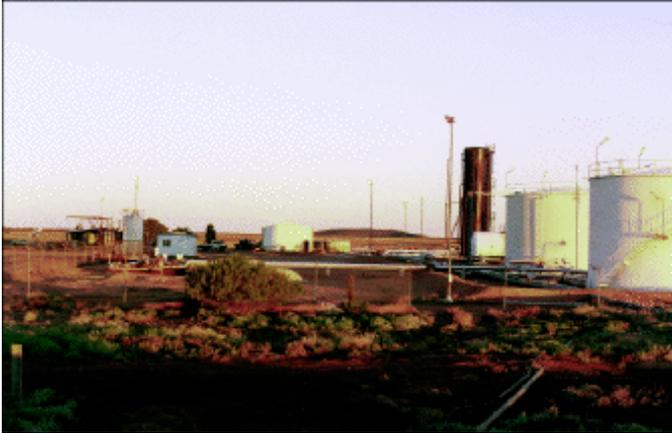
Jackson Tintaburra facility. Note bunding around storage tanks to contain any accidental spills and minimise contamination.

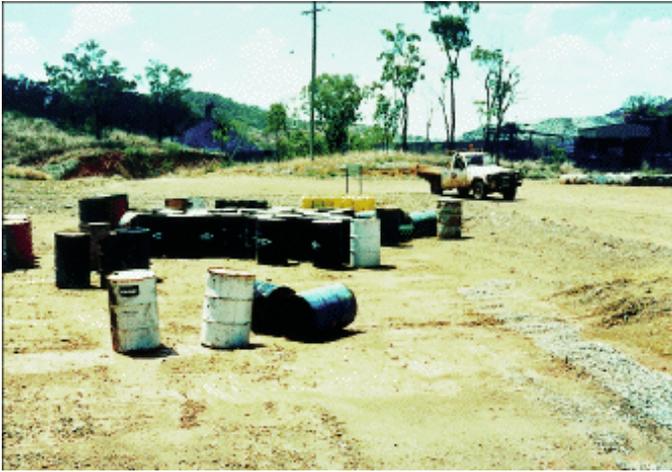
A used drum storage compound for containing drums prior to recycling or reconditioning.

All washed drums were then stored in a compacted soil (60cm) area, surrounded by a clay bund, until being collected by a local drum reconditioning company.

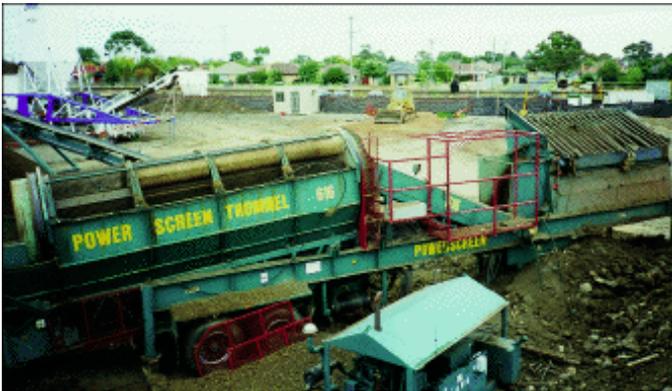
Remediation underway (March 1997) at the Ardeer site which was used for lead smelting and battery recycling during the 1950s to 1983.

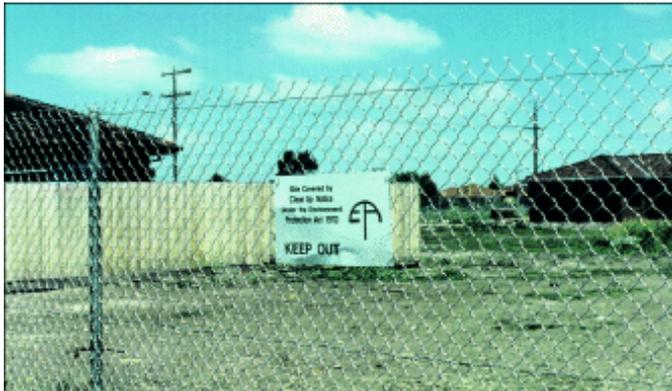
Ardeer site March 1989. The EPA Vic investigation showed high lead concentrations at the site. Note the need for fencing and signage to restrict public access and warn of danger.

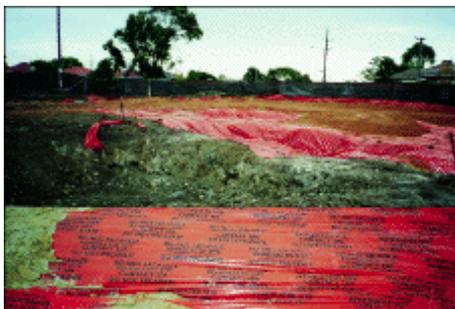
Contamination at the site was generally restricted to a shallow surface layer and removal of this layer eliminated the bulk of the contamination.

The contamination was found to be generally restricted to a shallow surface layer of fill (about 0.5m), and removing the fill resulted in the bulk of the contamination being eliminated. After remediation, validation testing showed that most of the site complied with residential use criteria, with the 95% UCL for the mean lead concentration being less than 300 mg/kg. After validation, a plastic warning barrier was placed at the base of the excavation and covered with clean fill and top soil. A site management plan was prepared to assist the city council with its future management of the site.

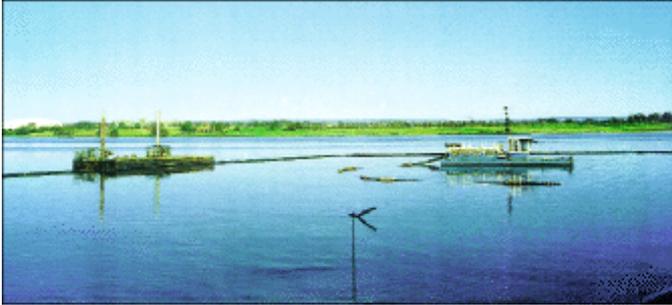
A silt curtain is used to contain suspended sediments when dredging contaminated sediments.

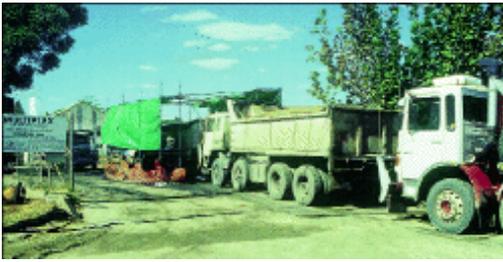
Trucks leaving the site have a tarpaulin cover to prevent contaminated soils becoming airborne and are subject to wheel washing.

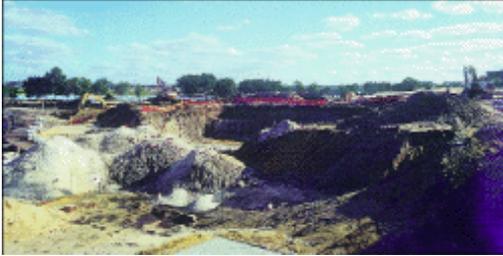
Extensive excavation of contaminated soils at the East Perth Gasworks site included 300 metres of the Swan River foreshore.

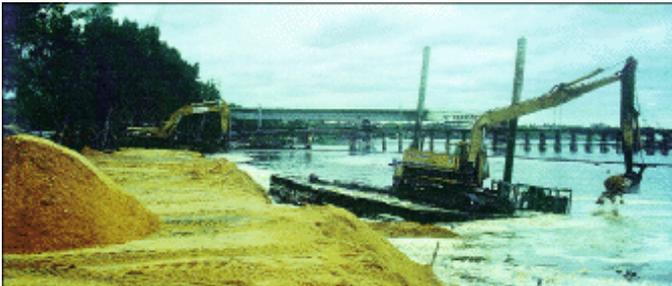
Excavating contaminated sediments from the Swan River with sediment curtain in the background.

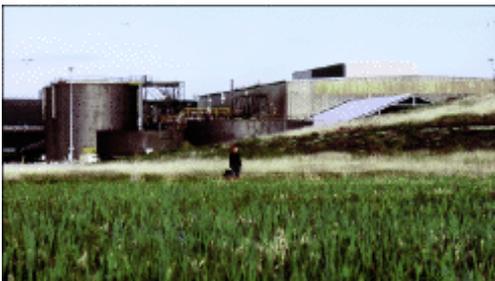
Officer inspects one of the revegetated mounds to the centre right. Batter angle 16 degrees assists revegetation and stability.

Best practice design of the containment system resulted in unobtrusive mounds with batter slope angles able to minimise the volume of infiltration. The batter angle (16°) also allowed for the revegetation of the soil cover and ensured the stability of the SCL material (stable at angles < 27°). A composite of high density, 1 mm thick polyethylene (HDPE) and clay was used for the cap and base. The HDPE liner alone is an effective barrier to the leachate but may be penetrated by sharp objects. A quality assurance and quality control program was implemented to ensure it was correctly installed and risk of puncture minimised.

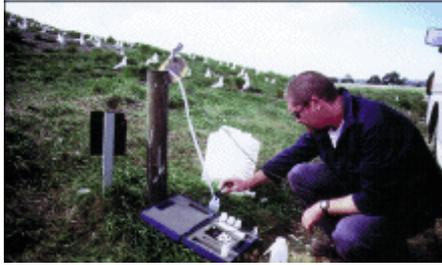
Monitoring groundwater adjacent to mounds is routinely carried out by environmental staff. Note plentiful bird life in background.

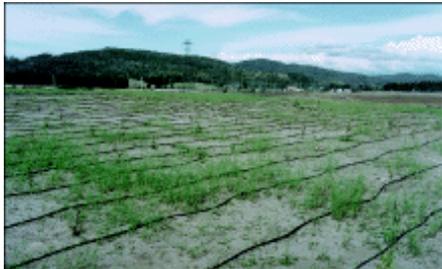
Ryecorn vegetation growth on spent cell liners (SCL) Encapsulation No #1 Vegetation early Feb 1996 with stockpiles 3 & 4 at centre rear. New vegetation requires irrigation.

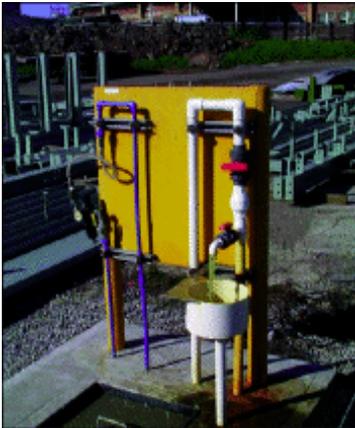
Part of the dewatering system for the deep aquifer showing typical well head layout, with pump controls on the left and sampling port on the right. The contaminated groundwater can be pumped from 12 such wells to the water treatment plant to remove dissolved metals.

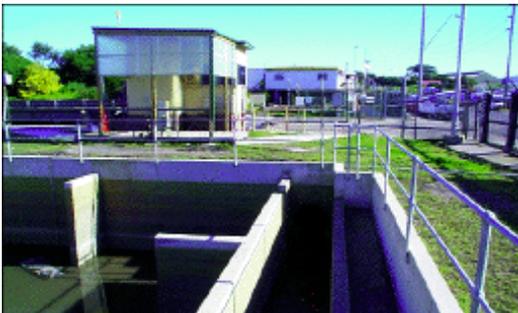
The interception pit is part of the system used to intercept and collect contaminated surface water and groundwater from the shallow aquifer. The system collects drainage from parts of the site, which has been contaminated by heavy metals. The collected water is pumped to the water treatment plant to remove metals.

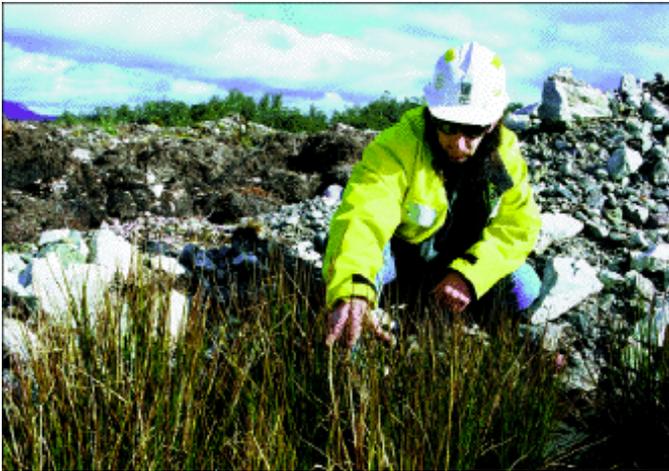
Native sedgeland species have successfully regenerated within the landfarm area, either directly from the seedbank within the contaminated peat, or from windblown seed. The predominant species featured is Juncus pauciflorus, commonly known as loose-flower rush.

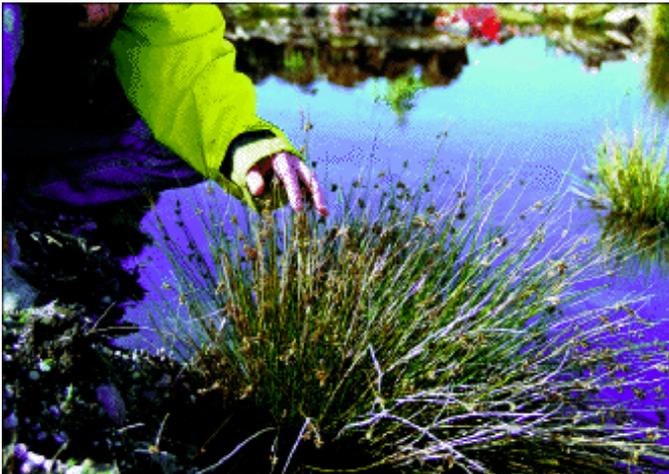
PHOTO: GOLDFIELDS (TASMANIA) LTD

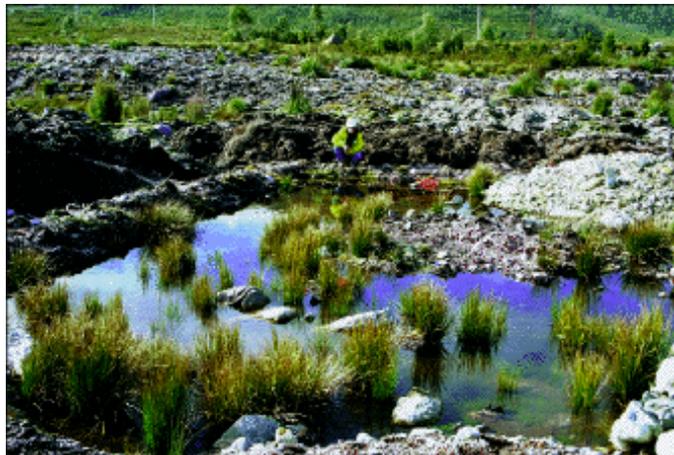
When the landfarm was established, the combined contaminated soil and peat was windrowed, fertilised and regularly turned to facilitate oxygenation and microbial activity. The landfarm is partially inundated with water for several months of the year. This photograph was taken in mid-winter, making it difficult to identify the windrowed material.

The area was regularly fertilised to encourage biological activity and turned to facilitate oxygenation. Since the landfarm was established, there has been noticeable growth of native button grass and other sedgeland species, which have germinated from the peat seed bank.

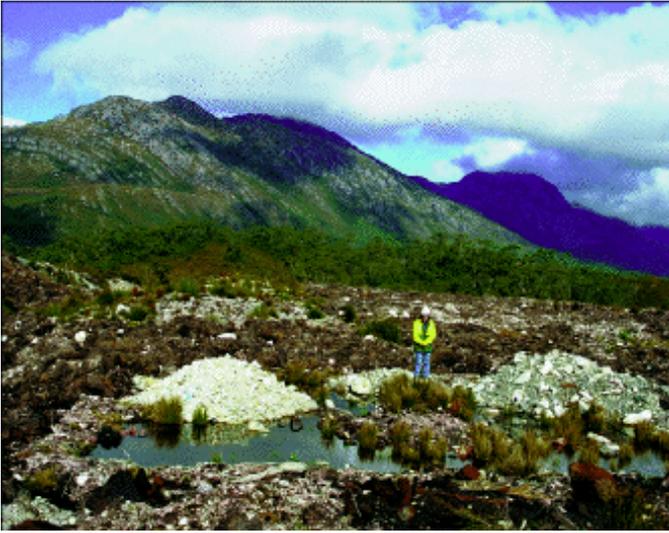
The landfarm area (foreground) is about 80 square metres and is located within the Newton peat storage works area. The Tyndall Ranges in the distance are south of the Henty Lease.
